Subject: RCRA Compliance Evaluation Inspection  
EPA ID Number: GAD 065-330-151

## RCRA COMPLIANCE INSPECTION REPORT

International Agile Manufacturing, LLC  
11021 Clito Road  
Statesboro, Georgia 30461

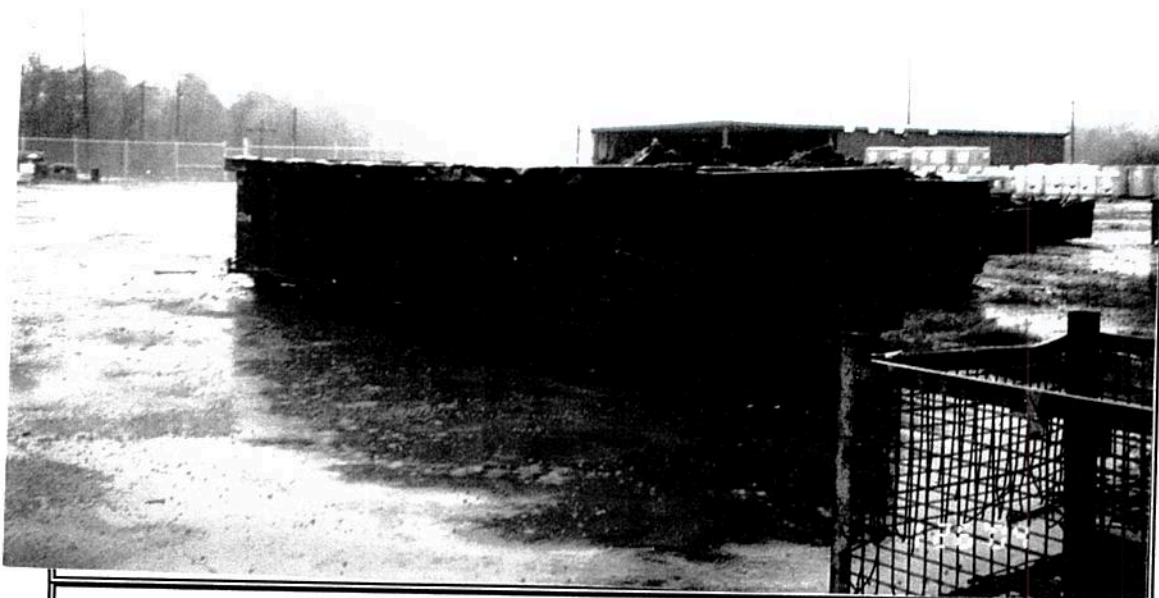
**Photograph #1**

- Sample 1 - Roll-off container of spent sandlike material. (Photo 1)
- Sample 2 - Roll-off container of slag. (Photo 1)
- Sample 3 - North End of Building below baghouse near the northwest corner of building. Results for this sample found this material to be hazardous for cadmium (23 ppm) and lead (48 ppm). (Photos 2 and 3)
- Sample 4 - West side of building about midway between the north and south ends of the main facility building near a fire hydrant. Results for this sample indicate this material to be hazardous for cadmium (1.1 ppm). The lead value was found to be 1.2 ppm. (Photo 4)
- Sample 5 - Area of drain to a ditch on the other side of fence.
- Sample 6 - Heavy fines from clarifier in bin which would be disposed.
- Sample 7 - Sample from filter press tank.

Northwest corner of building - roll-off storage area.

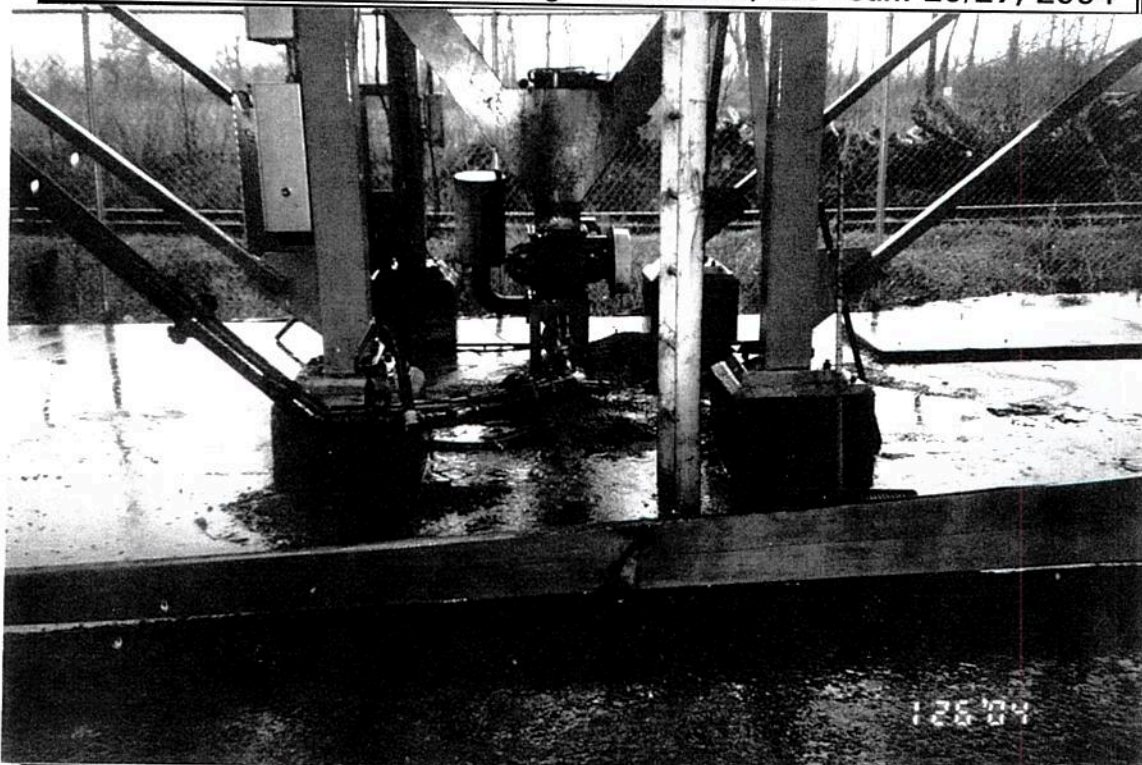
**Photograph #2**

Baghouse dust sampled beneath northernmost baghouse (Sample 3).

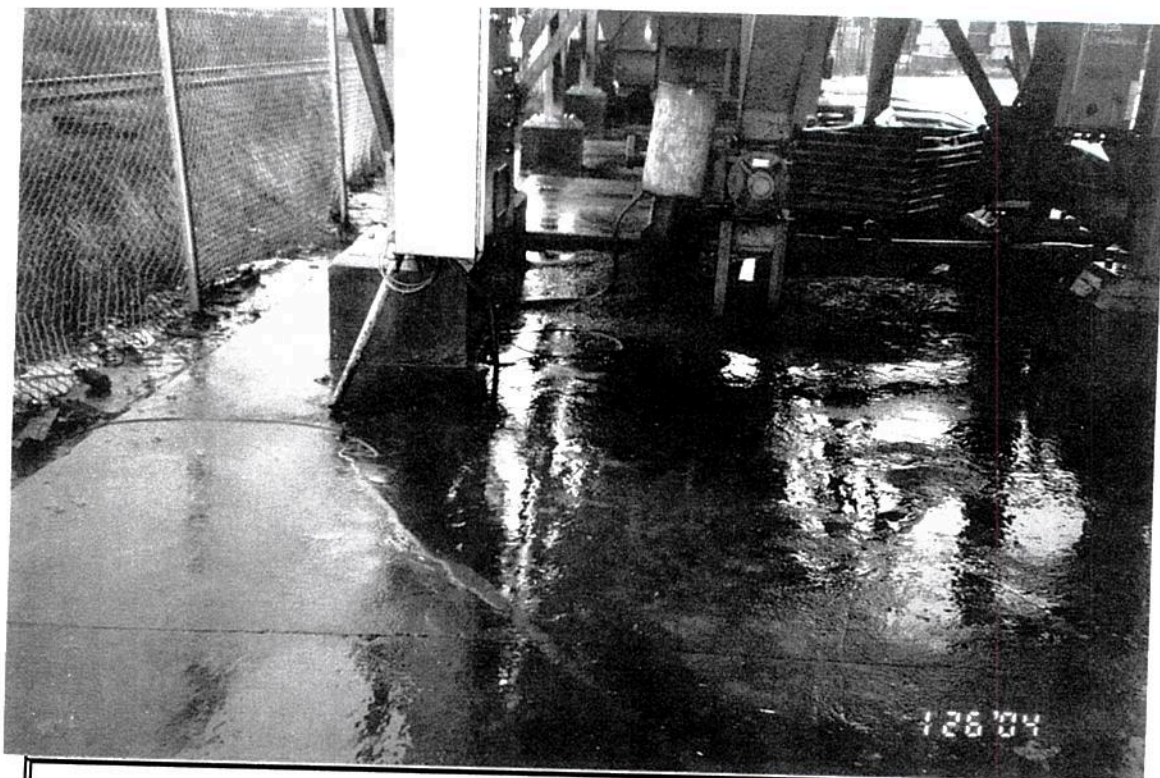
**Photograph #3**

Baghouse dust sampled beneath northernmost baghouse (Sample 3).  
**International Agyle Manufacturing - Statesboro, GA - Jan. 26/27, 2004**

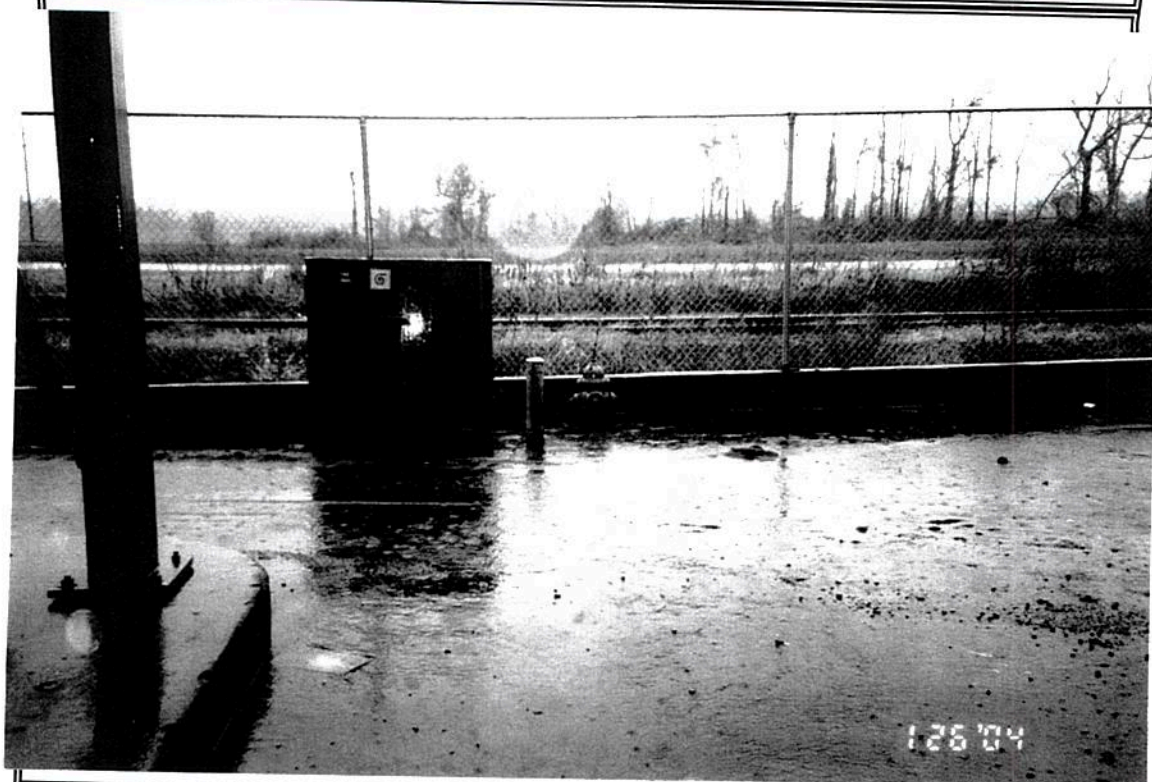
**Photograph #4**

Sampling point location near hydrant (Sample 4).  
**International Agyle Manufacturing - Statesboro, GA - Jan. 26/27, 2004**

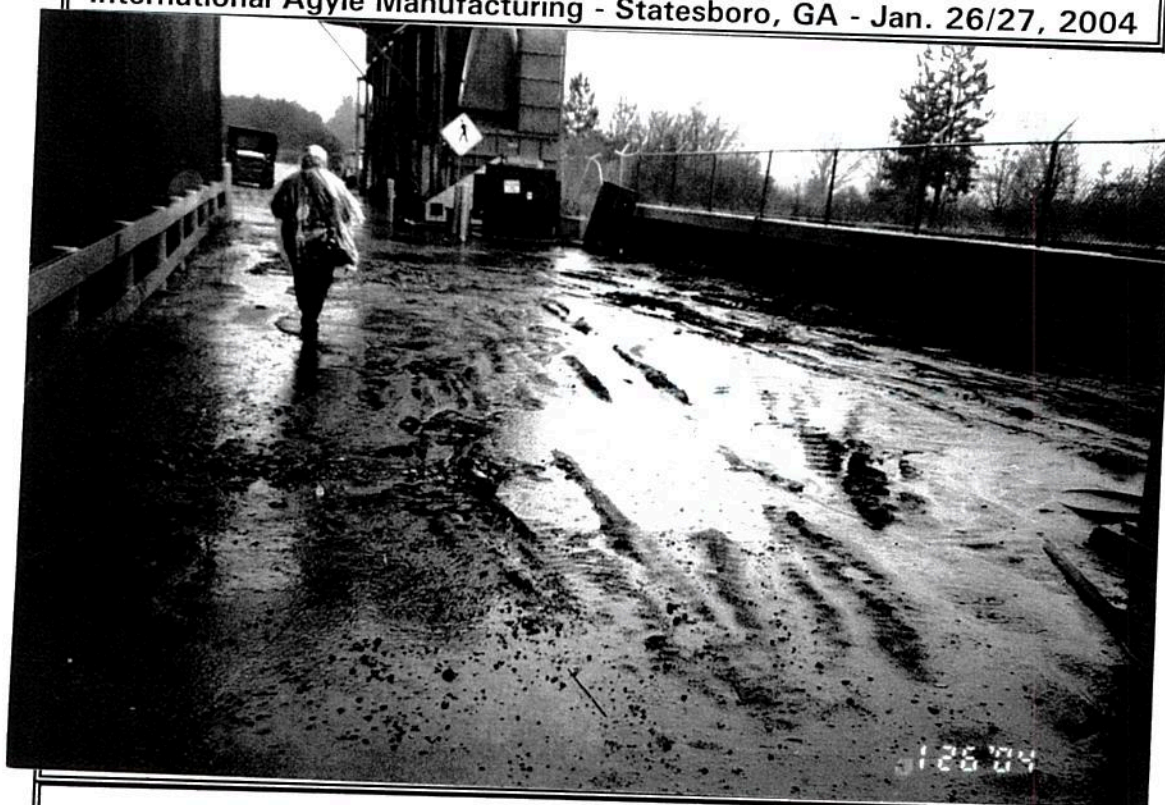
**Photograph #6**  
 Southward view of material on ground on west side of building to south of sample 4.  
**International Agyle Manufacturing - Statesboro, GA - Jan. 26/27, 2004**

The inspection team proceeded through the facility with flashlights to the baghouse area which is located on the west side of the facility. Upon observing materials having been disposed on the ground in varying amounts throughout this area of the facility the inspection team decided to take samples in several areas and tanks in and about this part of the facility. The samples would be analyzed to determine if they were characteristically hazardous for metals and/or to see if they exceed land disposal restriction levels. At the time of the inspection on January 26, 2003, a hard rain was occurring causing a significant amount of waste material to wash off the asphalt pad on the west side of the building into a small creek running adjacent to a facility fence on that side of the property.

**International Agile Manufacturing is in violation of Section 3005 of RCRA, 42 U.S.C. § 6925 for the storage and disposal of hazardous waste (D006 & D008) in a waste pile and surrounding areas on the west side of its facility. In addition, International Agile Manufacturing is in violation of the applicable regulations in 40 C.F.R. Parts 260-270, promulgated pursuant to Section 3005 of RCRA, for the storage/disposal of a hazardous waste.**

**International Agile Manufacturing is in violation of 40 C.F.R. § 268.40(a) (Section 391-3-11-.16) for the land disposal of prohibited waste on the west side of its facility.**

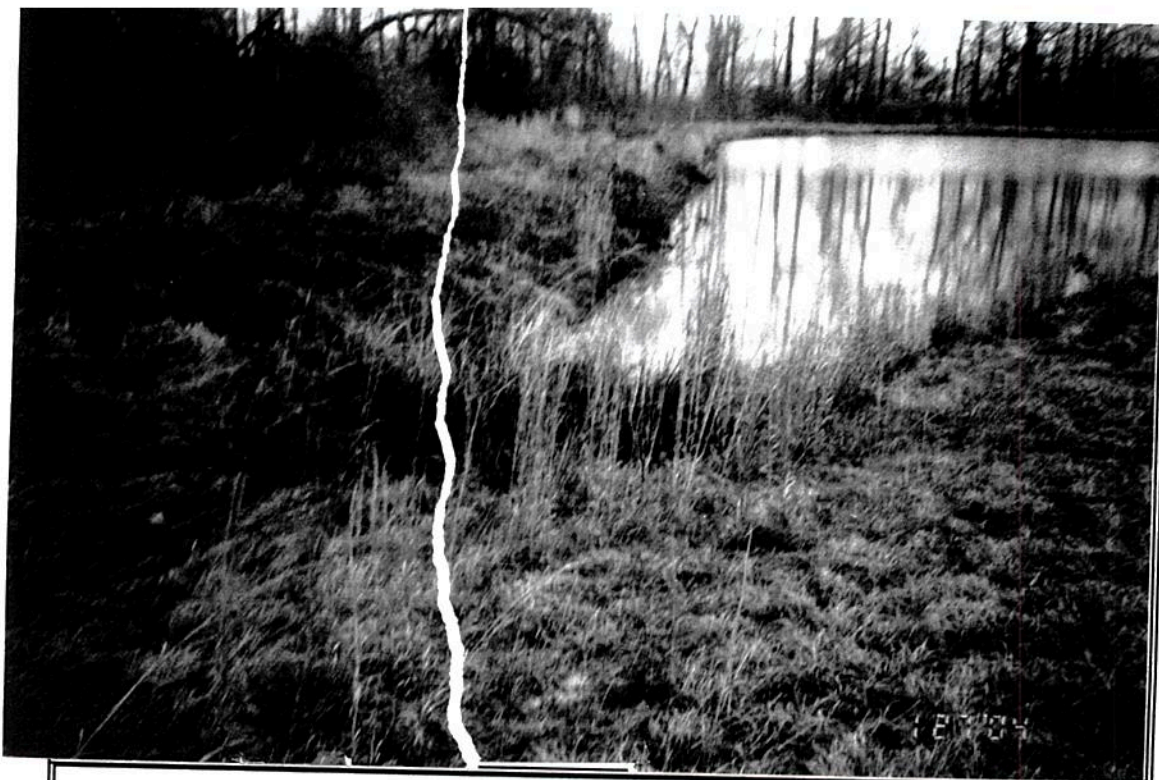
**Photograph #7**

Sample 8 - Inlet to run-off pond in landfill area. (Photo 7)

Inlet to run-off pond in landfill area.

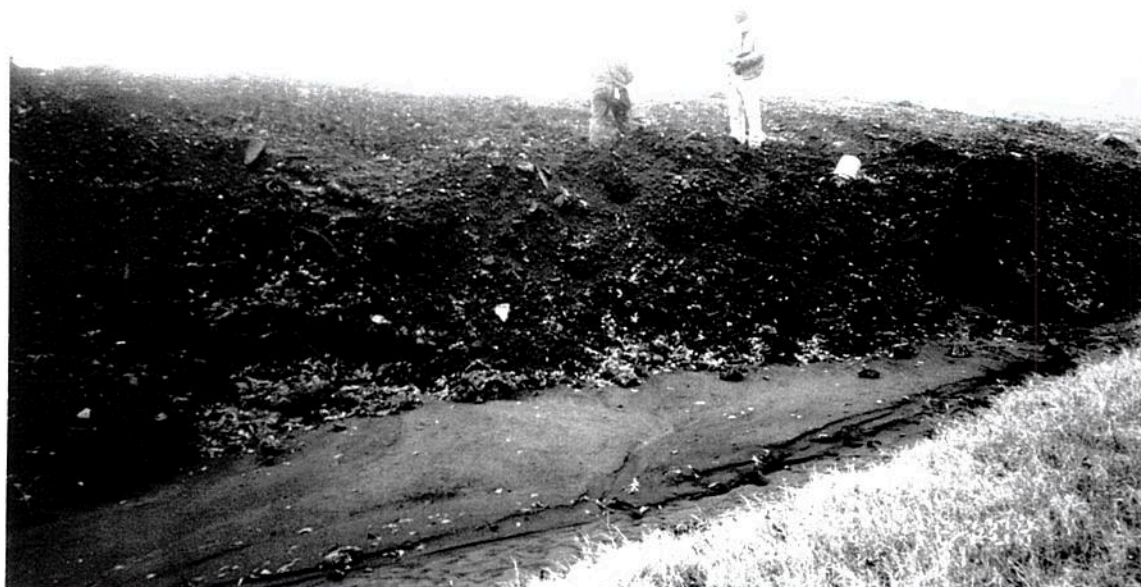
**Photograph #8**

Sample 9 - Landfill disposal pile area. (Photo 8)

Sample 10 - Landfill disposal pile area. (Cadmium 0.34 TCLP) (Photo 8)

One of the samples taken, Sample 10, had a TCLP cadmium level of 0.34 ppm. The regulatory level for the land disposal of cadmium in accordance with the land disposal restriction standards is 0.11 ppm.

International Agile Manufacturing is in violation of 40 C.F.R. § 268.40(a) (Section 391-3-11-16) for the land disposal of prohibited waste. International Agile Manufacturing land disposed a hazardous waste which was not treated to the applicable treatment standards.

Landfill disposal pile area.

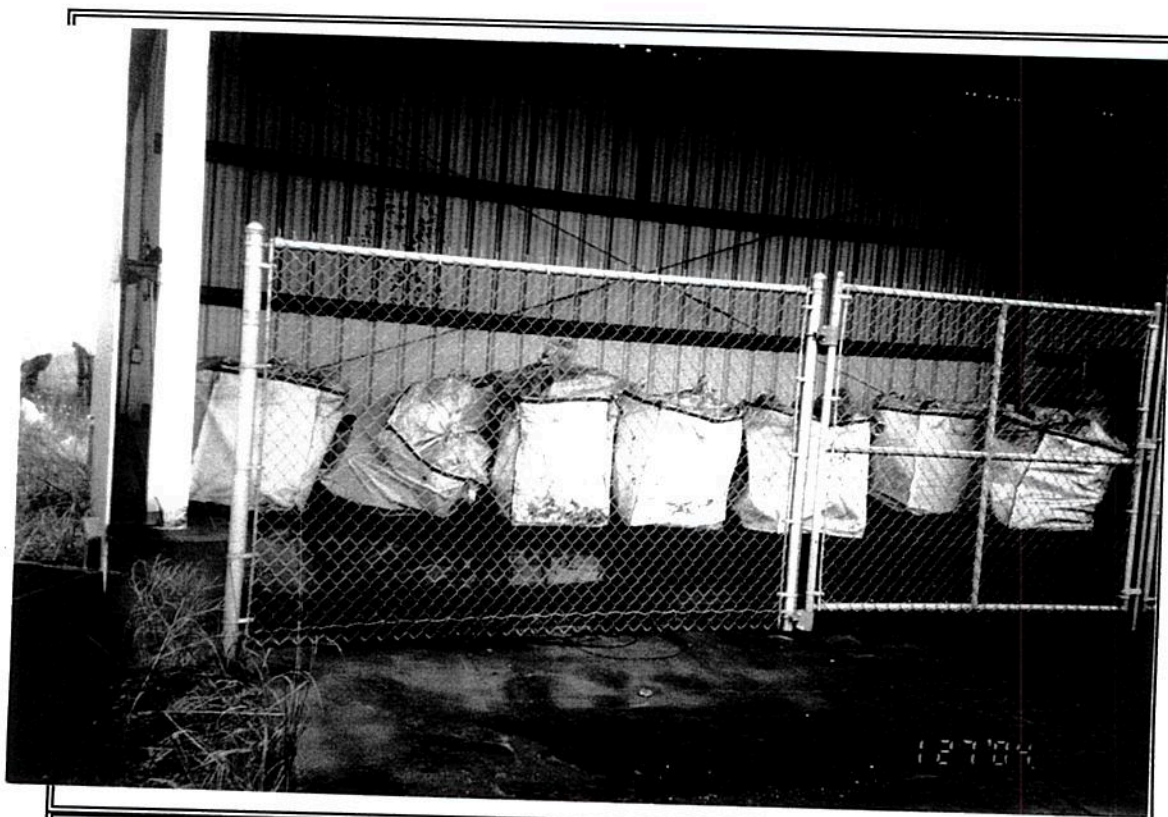
**Photograph #9**

This area consisted of a roofed, three sided, metal structure on a concrete pad. At the time of the inspection, fourteen (14) bags of hazardous waste were contained within the building. Ten of the cubic yard bags contained spent baghouse bags. Four of the bags contained baghouse dust. (Photo 9). All of the bags were being stored on top of wooden pallets. Each of the bags were labeled with the words "Hazardous Waste." The bags were not labeled with accumulation start dates. **International Agile Manufacturing has failed to adhere to a condition for exemption from RCRA § 3005 given in 40 CFR § 262.34(a)(2) (Section 391-3-11-.08 (a)).** This regulation requires hazardous waste generators to clearly mark each hazardous waste container with the accumulation start date. As such, the facility is illegally storing hazardous wastes in violation of RCRA § 3005. **International Agile Manufacturing has failed to adhere to a condition for exemption from RCRA § 3005 given in 40 CFR § 265.174, as incorporated by 40 CFR § 262.34(a)(1)(i).** This regulation requires the facility to inspect containers of accumulated hazardous waste for leaks and deterioration on a weekly basis. As such, the facility is illegally storing wastes in violation of RCRA § 3005.

Hazardous waste container storage area.
